Subject: September 10, 2014 Compliance Evaluation Inspection

CWA COMPLIANCE EVALUATION INSPECTION REPORT
U.S. ENVIRONMENTAL PROTECTION AGENCY, REGION 5

Northwest Illini Feedlots

September 10, 2014

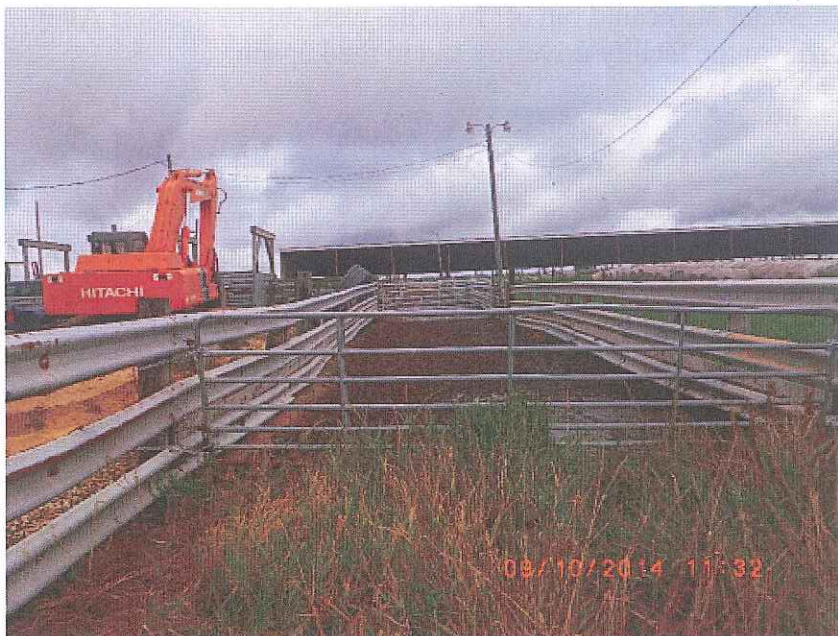
1: IMGP1363

EPA began the walkthrough on the south side of the Sort Alley. Surface flow off the Sort Alley would flow to the south and to a pipe at ground level. The pipe would transport any manure or process wastewater to the Lagoon directly to the south.

Description: Sort Alley is slanted so surface runoff would flow to the south.

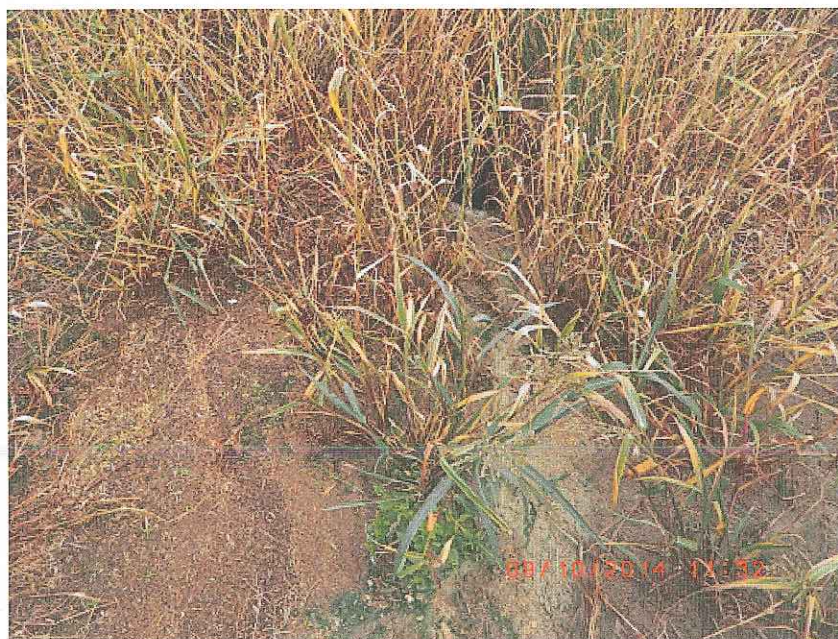
2: IMGP1364

Description: Flow off the Sort Alley goes into this inlet south of the alley.

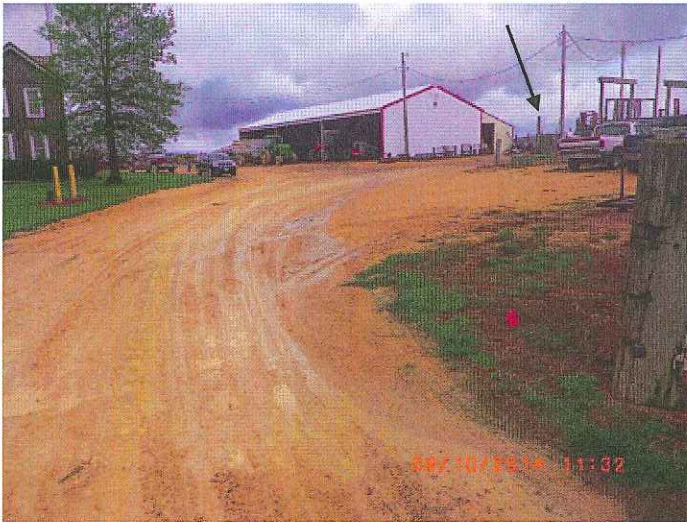
3: IMGP1365

Manure and process wastewater also could run off from the west side of the Sort Alley. It would then flow south down the facility driveway and to the Lagoon.

Description: Process wastewater from the west side of the Sort Alley (black arrow) would flow along the driveway to the south and east and then flow to the Lagoon.

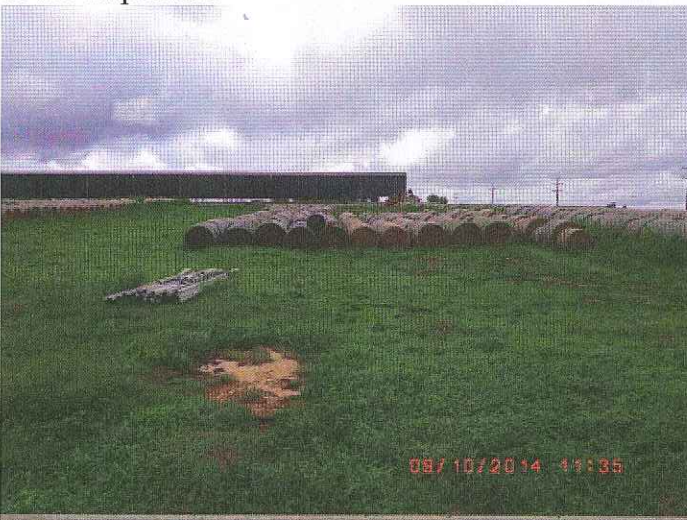
4: IMGP1366

South of Barn B, former dirt feedlots have been abandoned as animal confinement areas and now are where round bales are stored. The area was completely vegetated on the day of the inspection.

Description: Round bales are stored in the yard south of Barn B.

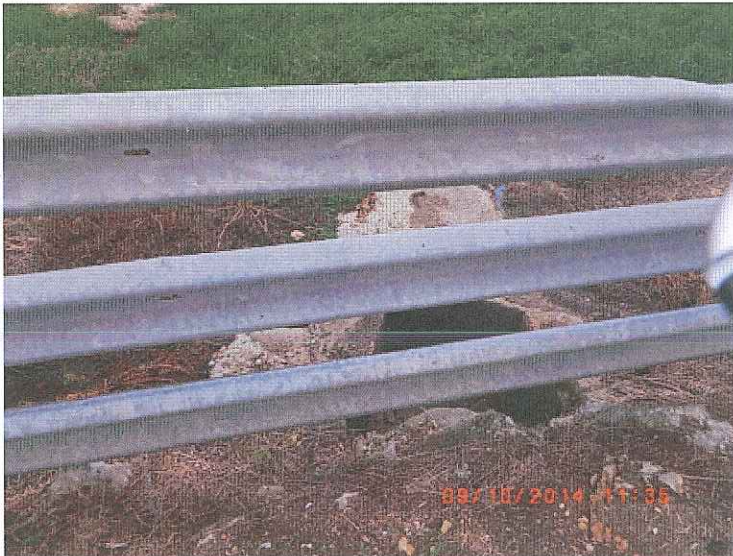
6: IMGP1368

A storm water inlet at the southeast corner of the former feedlots transports flow to under the facility driveway and to the yard to the south. The flow of storm water would flow to the south and to Straddle Creek.

Description: Storm water inlet in the southeast corner of the yard.

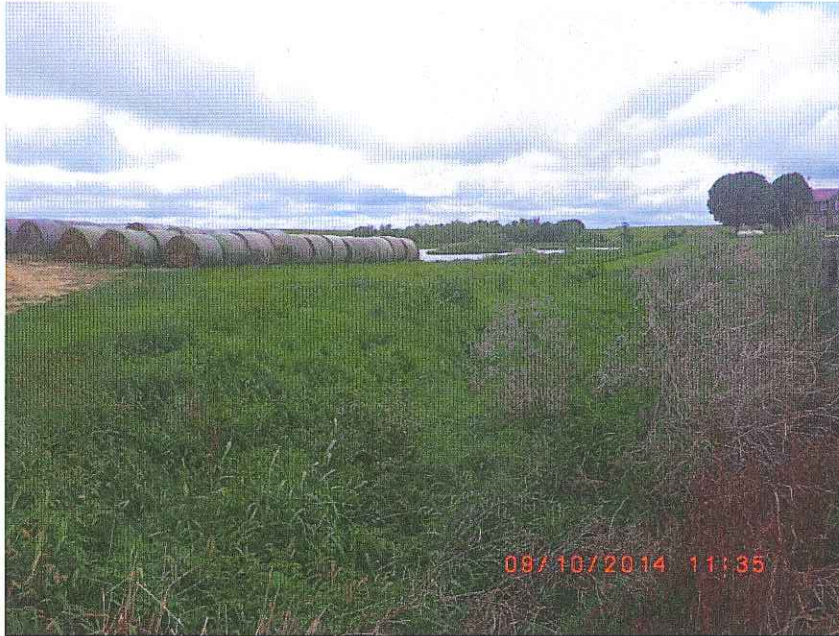
7: IMGP1369

Description: Storm water outlets in grassed area south of the facility driveway and flows to Straddle Creek.

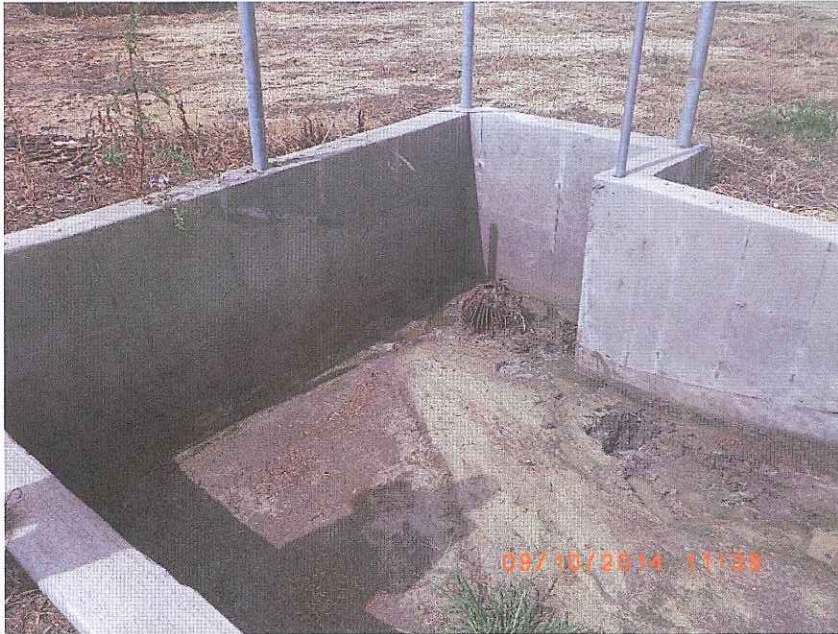
8: IMGP1370

Corn silage is stored in concrete bunkers south of the facility driveway. Additional commodities are stored in a Commodities Barn in the Feed Storage Area. Process wastewater from the Feed Storage Area flows to the north and to a concrete Catch Basin. A dirt berm on the ground directs the flow to the Catch Basin. A pipe at the bottom of the basin transports the process wastewater to the Lagoon.

Description: Catch Basin for silage leachate is located at the northwest corner of the Feed Storage Area.

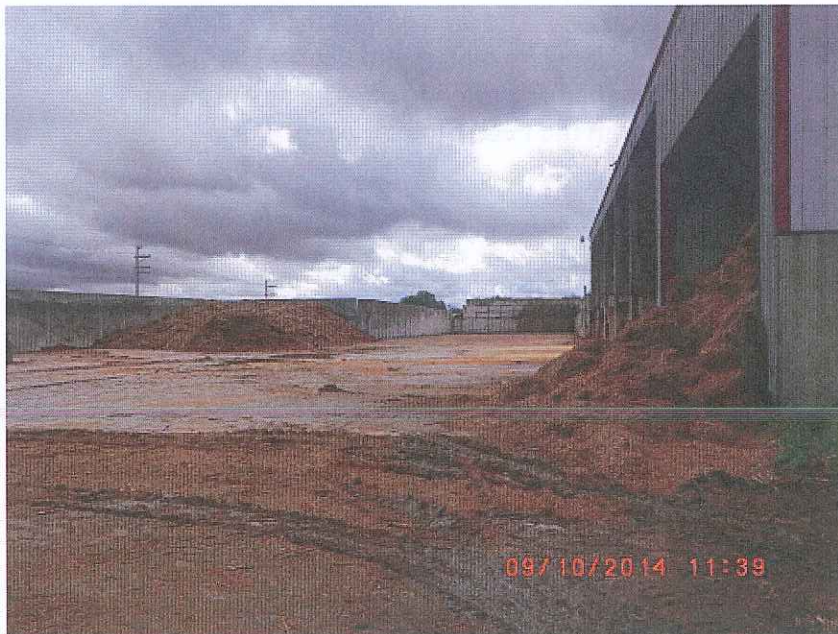
9: IMGP1371

Description: Silage leachate flows over the ground to the Catch Basin.

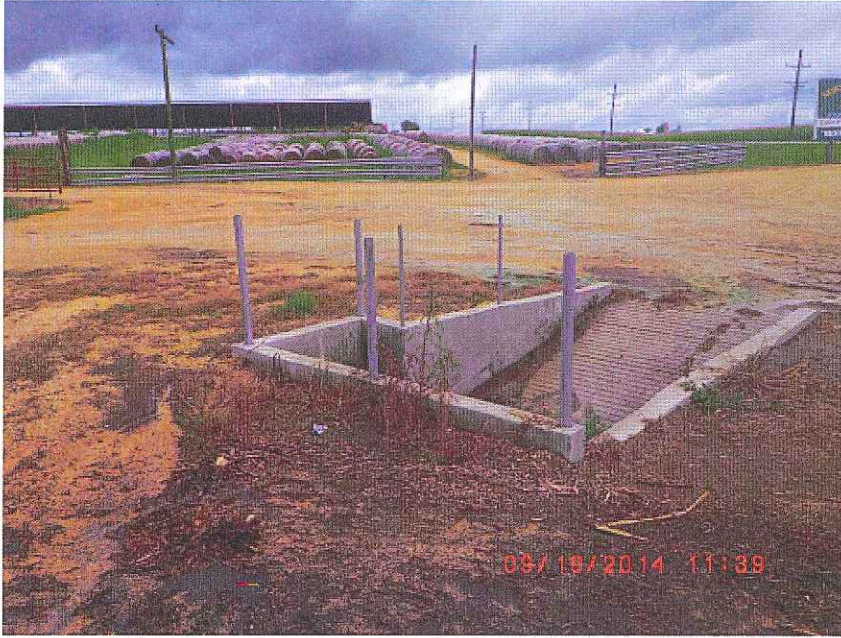
10: IMGP1372

Description: Silage leachate flows over the ground to the Catch Basin.

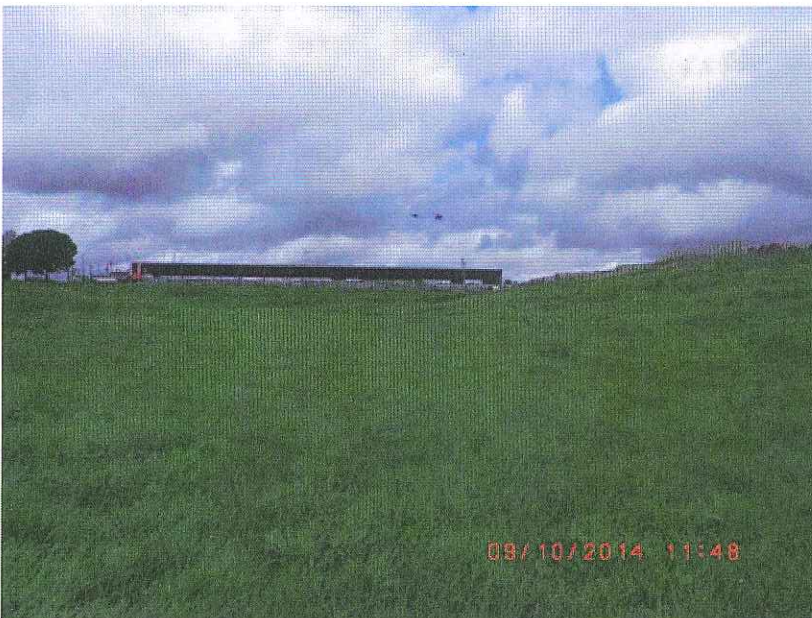
14: IMGP1376

Description: The facility owners have created a secondary ditch to collect any runoff from the round bale area so it won't access the roadside ditch.

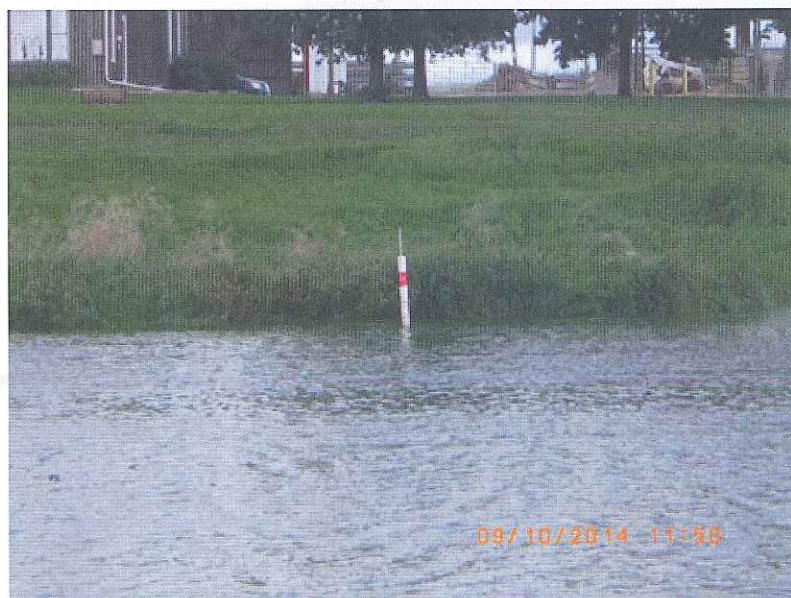
16: IMGP1378

EPA walked to the west to the south side of the Lagoon. EPA observed the depth marker in the Lagoon and noted that there was approximately four feet of freeboard.

Description: Capacity depth marker in the Lagoon.

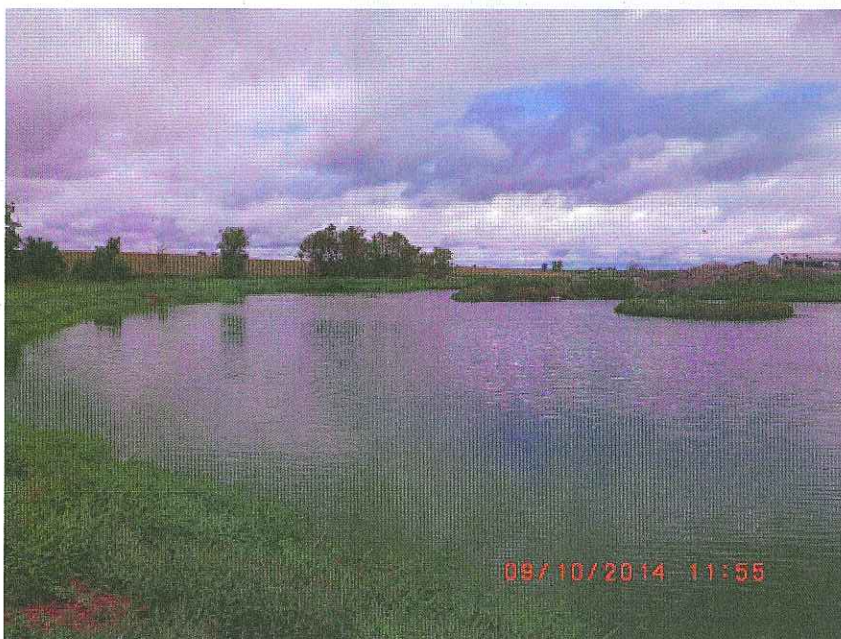
17: IMGP1379

Description: Lagoon has over four feet of freeboard in it.

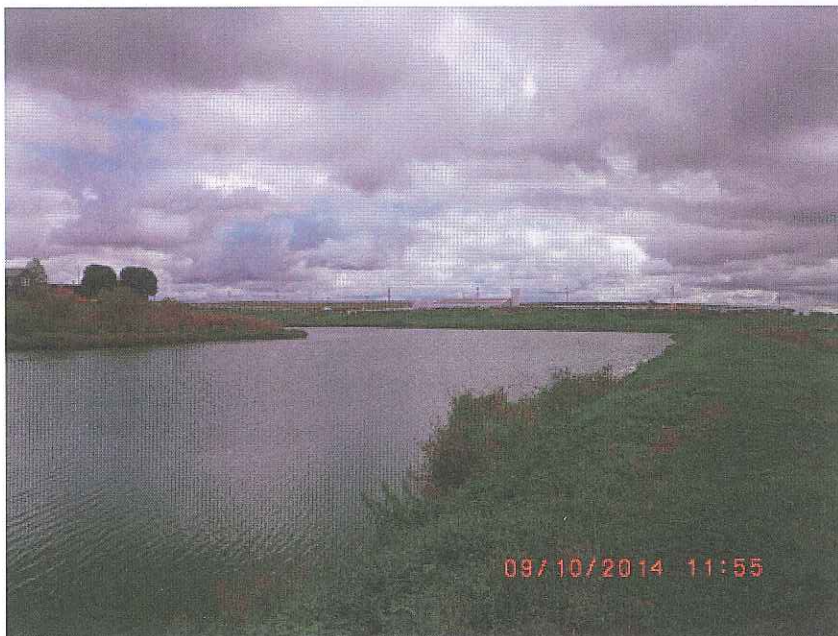
18: IMGP1380

Description: Lagoon has over four feet of freeboard in it.

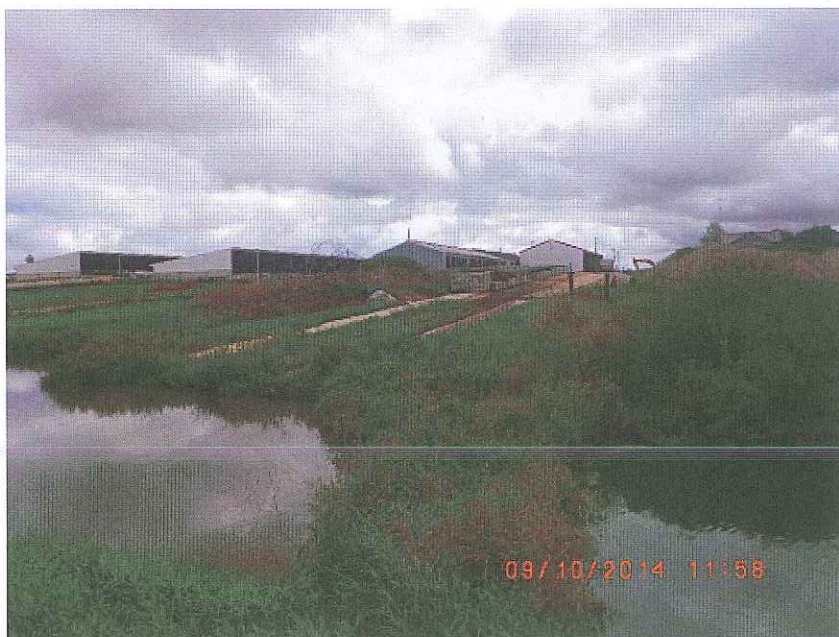
19: IMGP1381

Description: Berm across the northwest part of the Lagoon allows solids to settle in the smaller part of the Lagoon.

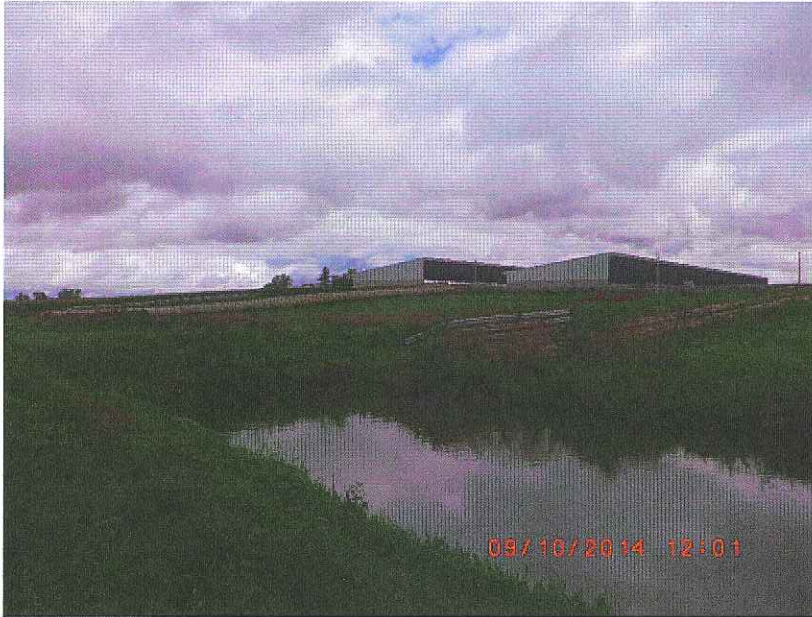
20: IMGP1382

Description: Process wastewater from the Sick Barn and Pens 4, 5, and 6 flow to the west directly to the bermed off part of the Lagoon.

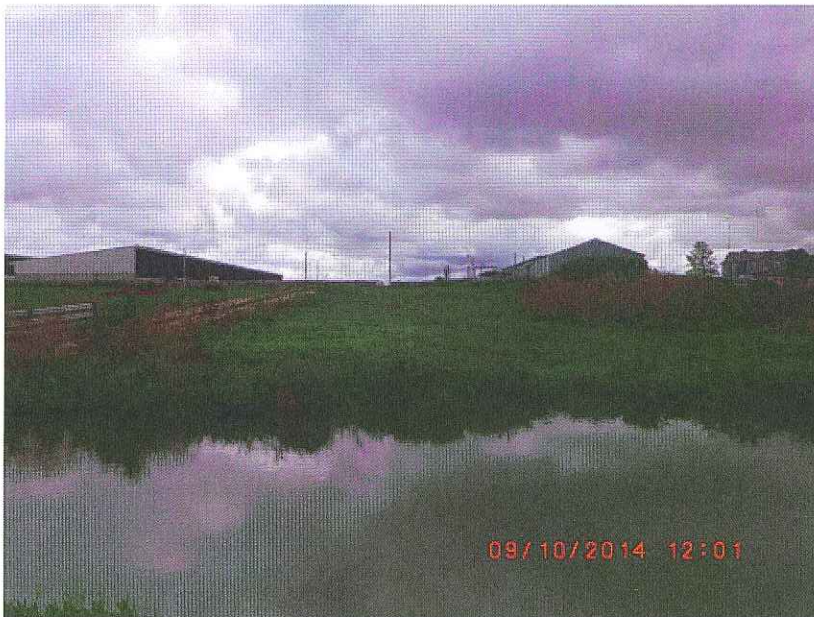
21: IMGP1383

Description: Process wastewater from the Sick Barn and Pens 4, 5, and 6 flow to the west, down the grassed hill, to the bermed off part of the Lagoon.

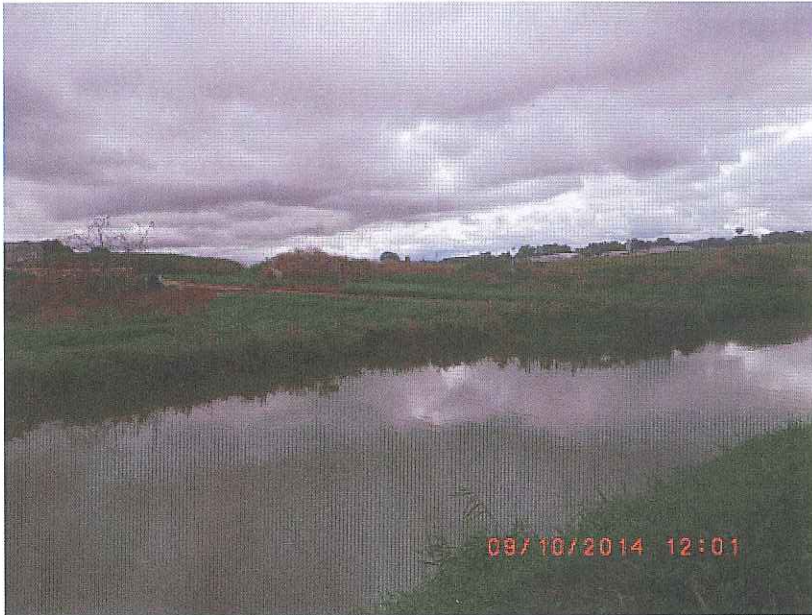
22: IMGP1384

Description: The bermed off part of the Lagoon allows solids to settle out before overflowing into the main part of the Lagoon.

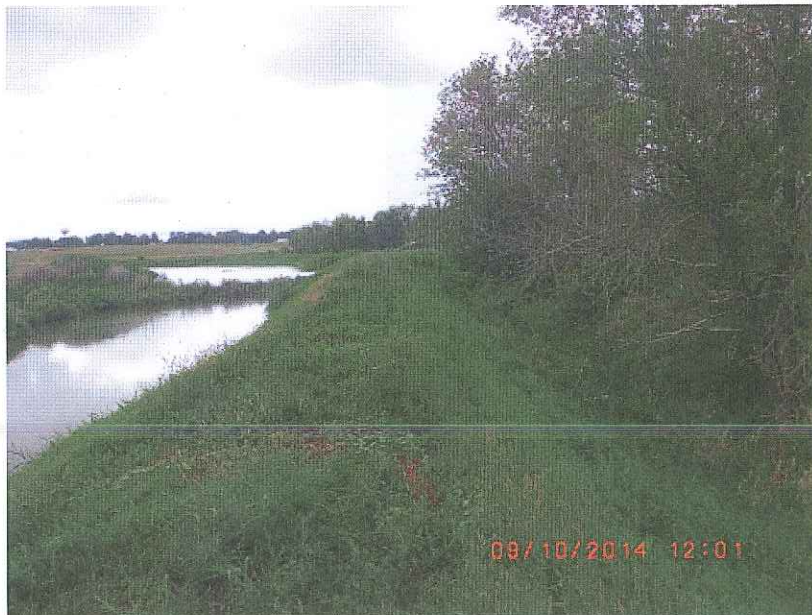
23: IMGP1385

On the day of the inspection the berms were well mowed and there was no woody vegetation growing in them.

Description: Lagoon berms are well maintained with no woody growth and the vegetation is kept mowed.

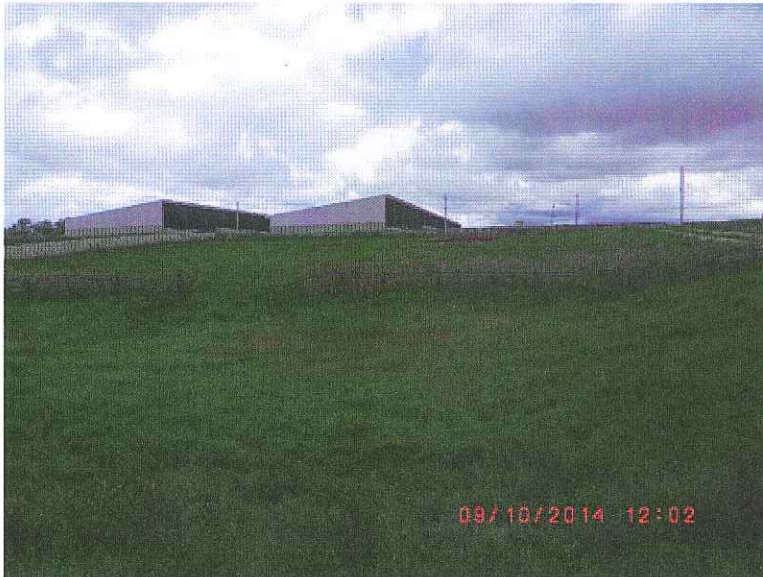
24: IMGP1386

Earthen feedlots on the west side of the facility are not used to confine animals anymore. They have been vegetated.

Description: The lots to the west of the barns are not used to confine animals anymore.

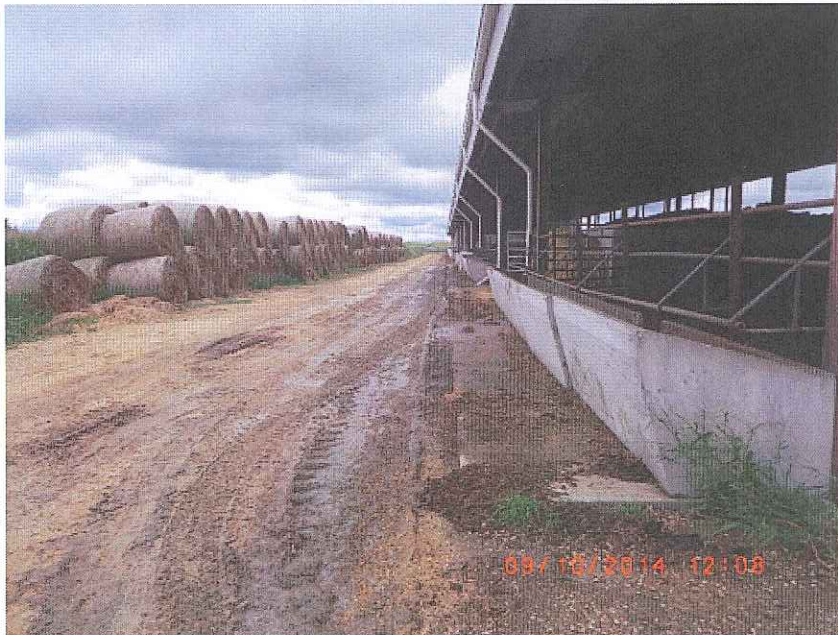
26: IMG1388

Description: Round bales are stored on the north side of Barn A. Note the downspouts from the gutters on the barn. Roof water is directed to the downspouts which are tied to an underground pipe which outlets the storm water to the intermittent unnamed tributary.

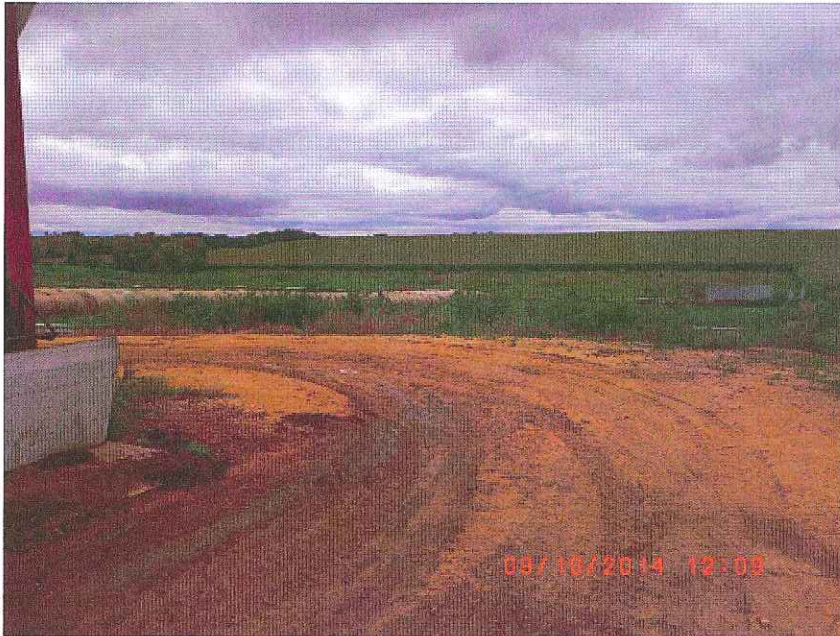
27: IMGP1389

The barns have gutters on them and the downspouts are tied to an underground pipe which outlets the storm water at the intermittent unnamed tributary northwest of the former dirt feedlots on the west side of the facility.

Description: Downspouts from gutters outlet near the intermittent unnamed tributary near the northwest corner of the dirt lot to the west of Barn A.

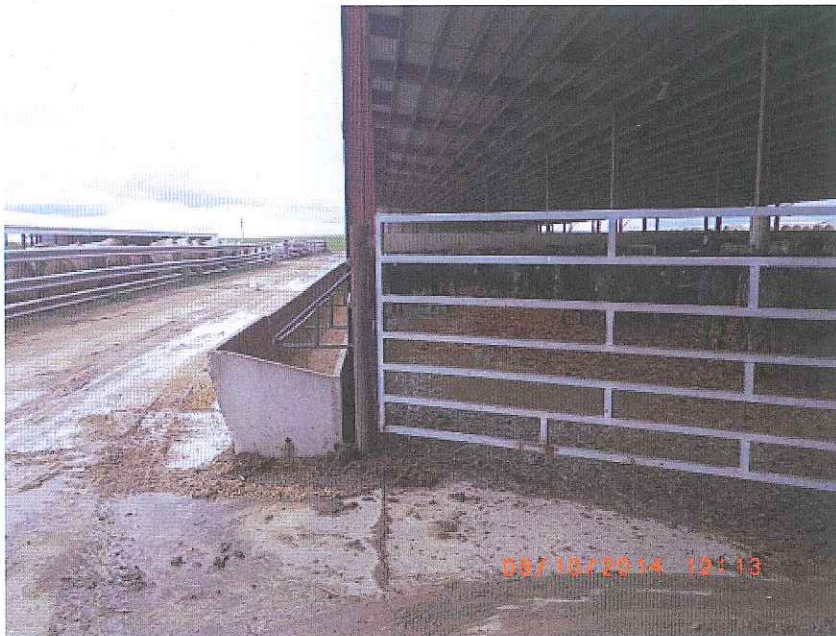
29: IMGP1391

Description: Bed pack in the middle of the barn. The barn edges are scraped daily.

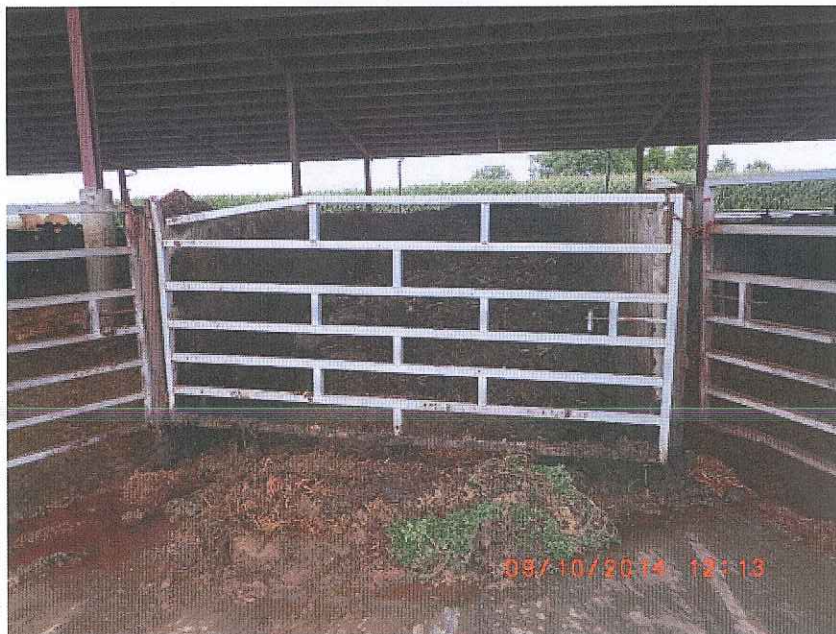
30: IMGP1392

Description: Scraped manure and bed pack is stacked in concrete bunkers inside the barn.

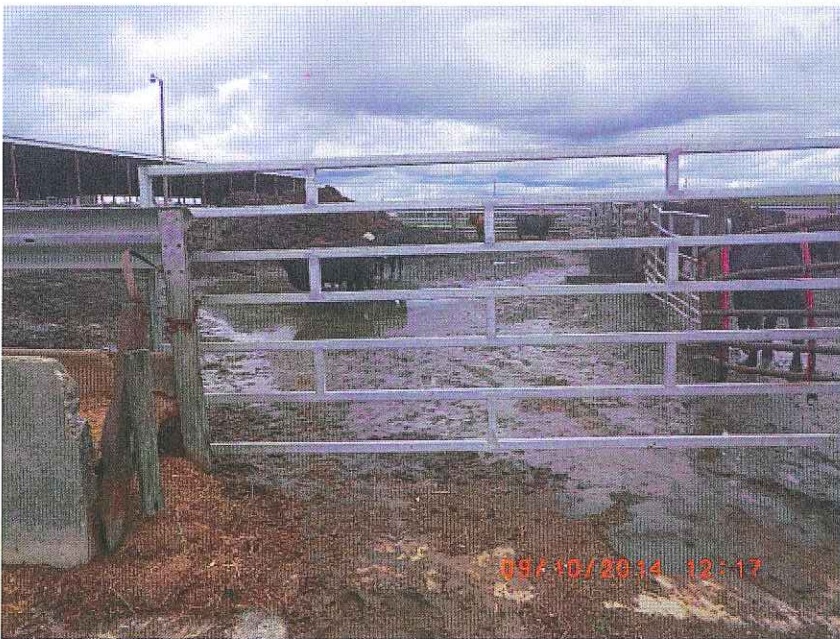
35: IMGP1397

Description: Runoff from Receiving Pen 14 flows to the southwest under the gate.

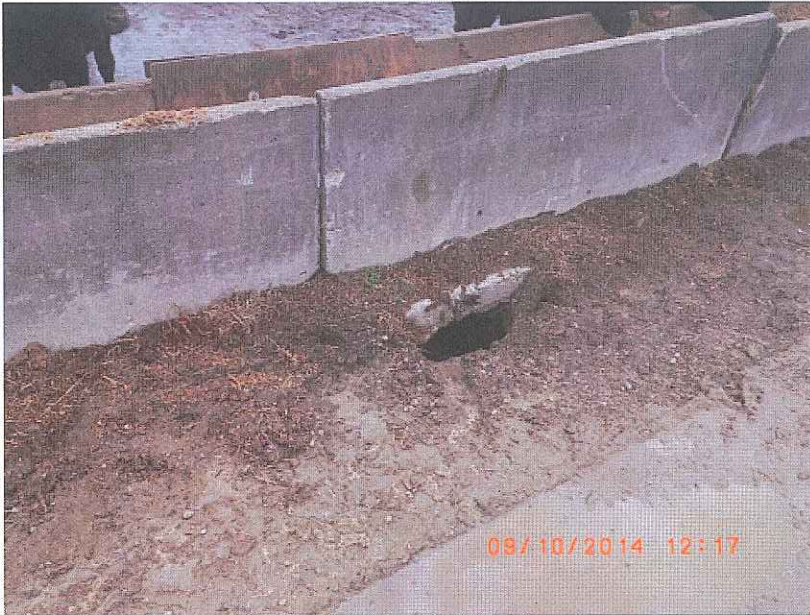
36: IMGP1398

Description: Flow from Receiving Pen 14 flows to an inlet outside the northwest corner of Receiving Pen 16.

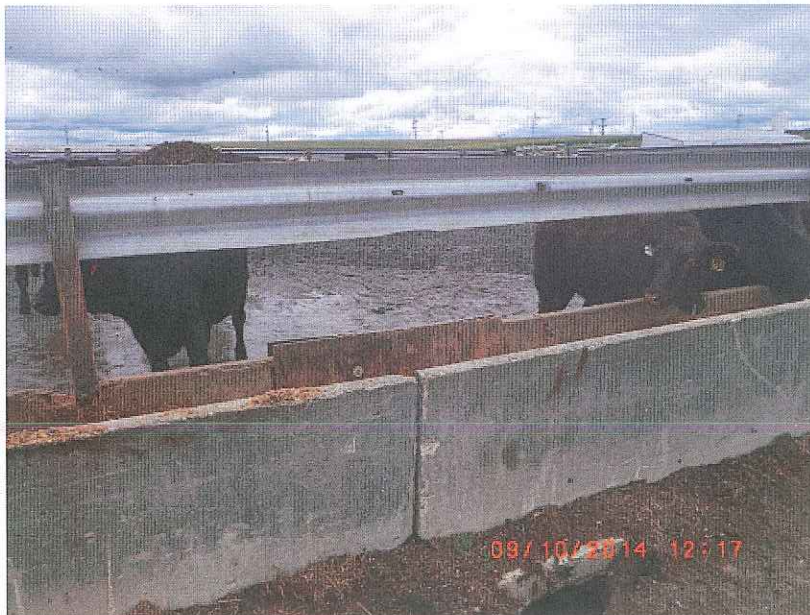
37: IMGP1399

Description: Inlet for the runoff from Receiving Pen 14 at ground level by Receiving Pen 16.

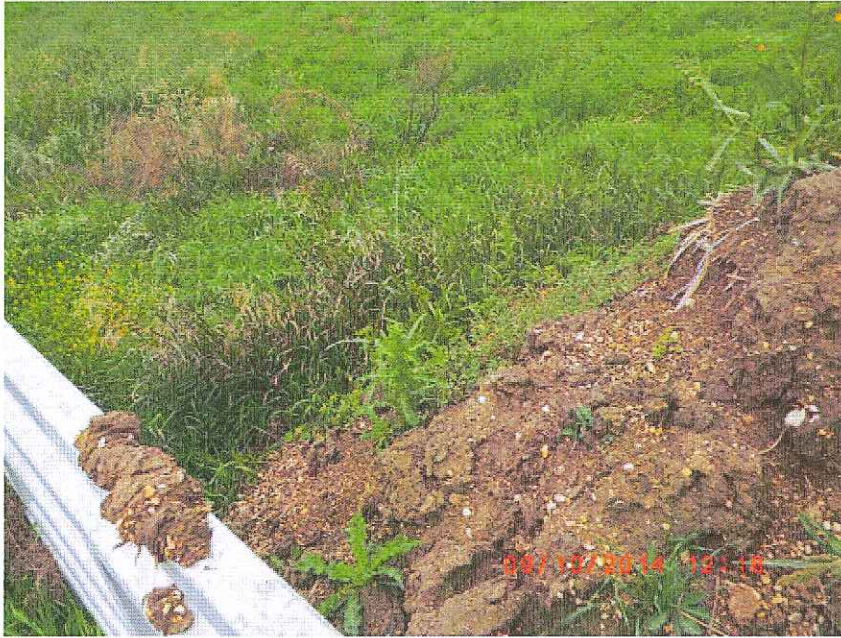
38: IMGP1400

Description: Pipe for flow from Receiving Pen 14 outlets in the hillside on the west side of the driveway. The hillside flows to the northern portion of the Lagoon. Outlet is under the vegetation.

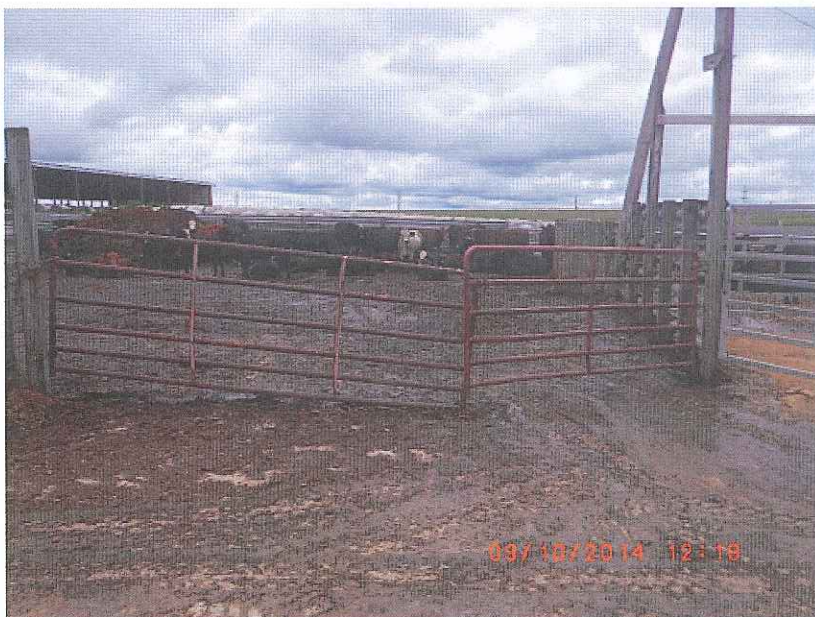
39: IMGP1401

Runoff of manure and process wastewater from Receiving Pen 16 flows to the southwest where some will flow into the Sort Alley. As described at the beginning of the walkthrough portion of this inspection report, manure and process wastewater from the Sort Alley flows to the south to a pipe inlet at ground level and from there to the Lagoon.

Description: Runoff from Receiving Pen 16 flows to the west and southwest under the gate.

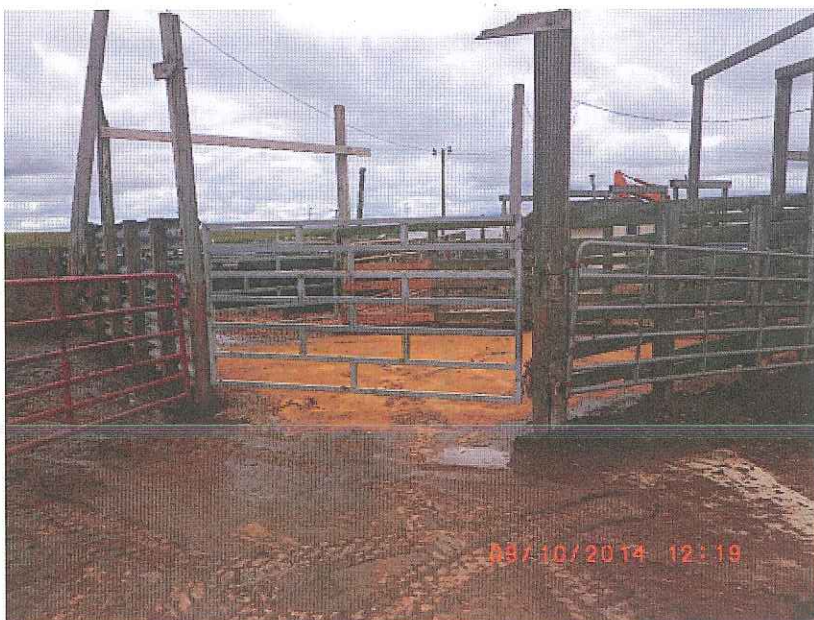
40: IMGP1402

The portion of manure and process wastewater that doesn't flow into the Sort Alley, flows to the south and down the hillside to the Lagoon.

Description: Some of the runoff from Receiving Pen 16 flows into the Sort Alley. Some will bypass the Sort Alley and flow to the south down the driveway.

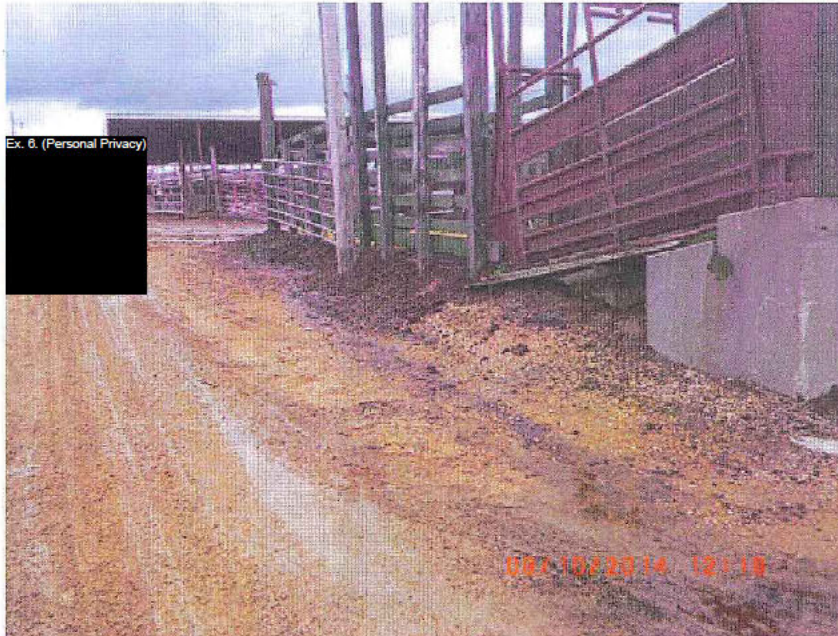
41: IMGP1403

Description: Runoff from Receiving Pen 16 flows down the driveway and would eventually flow to the Lagoon.
